Report No. APG-MT-3294

FINAL REPORT ON
PRODUCT IMPROVEMENT TEST

TRUCK, UTILITY, 1/4-TON, 4X4, M151 SERIES WITH
MODIFIED INDEPENDENT REAR SUSPENSION SYSTEM

JULY 1969

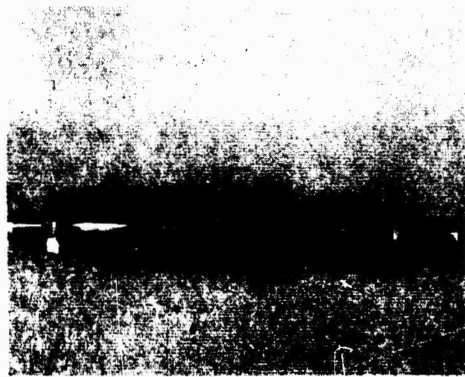
Figure III-21: Speedometer Drive Gear Failed when Parking-Brake Drum Retaining Nut Came Loose On M151A1 after 11,741 Test Miles.

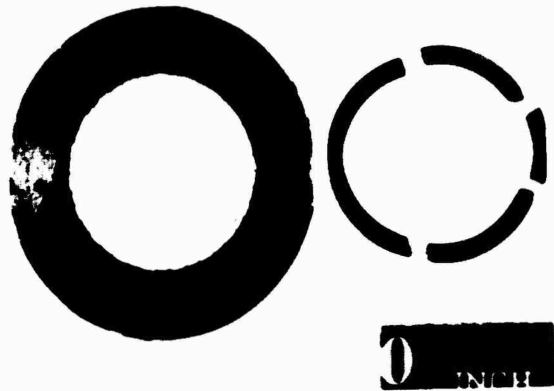
(3) Transmissions. Transmission failures occurred on all five test vehicles. (Deficiency) The output shaft snap ring retainer installed on the M718 vehicle at APG after test initiation, failed at 9,625 miles. (Deficiency)

Figure III-23: Broken Transmission-Output Shaft Snap Ring and Snap-Ring Retainer On M151A1C after 9625 Test Miles.

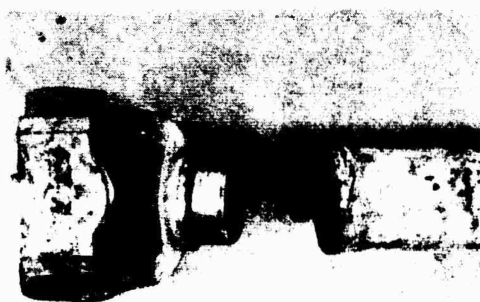
Figure III-24: Weld Failure
On Front Propeller Drive Shaft
On M151A1 after 3475 Test Miles.

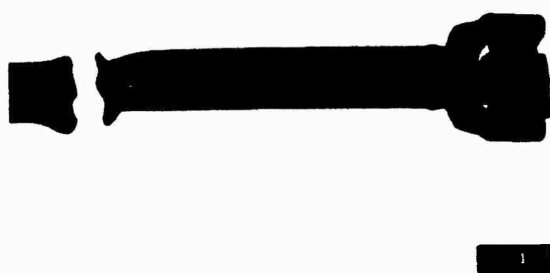
Figure III-26: Broken Front
Propeller-Drive Shaft On M151A1C
after 8247 Test Miles.

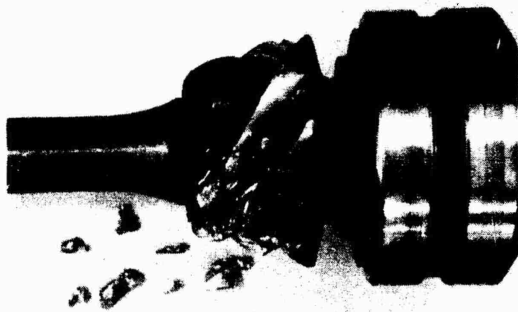
Figure III-32: Broken Rear-Differential Pinion Gear On M151A1 after 6930 Test Miles.

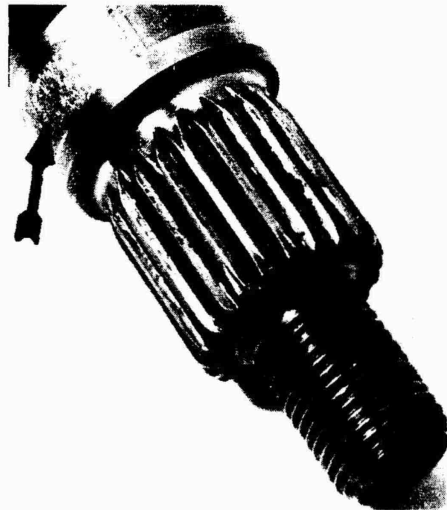
Figure III-33: Arrow Shows Worn Rear-Differential Pinion-Gear Shaft On M151A1 after 18,341 Test Miles.

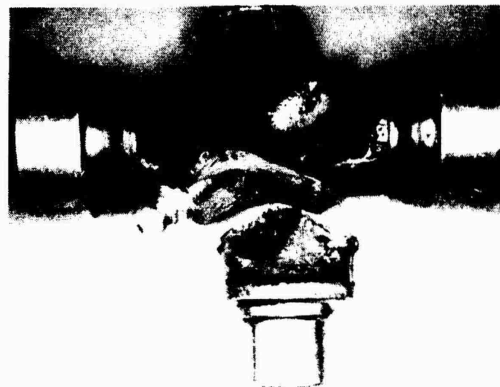
Figure III-35: Broken Right Rear Wheel-Drive Shaft Outboard Universal Joint Cross On M151A1 after 2144 Test Miles.

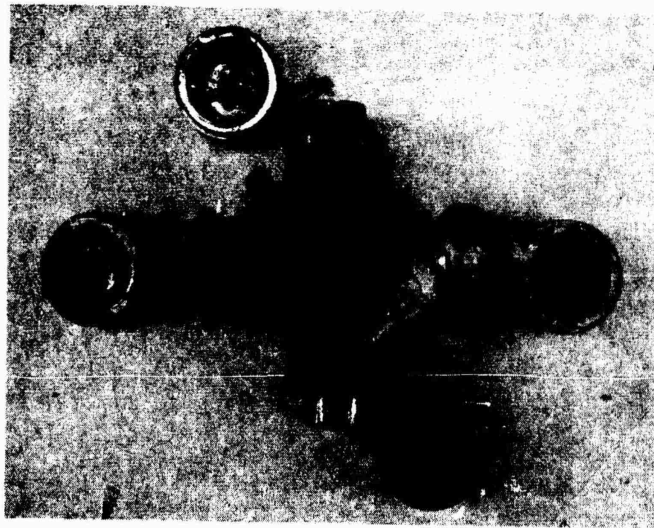
Figure III-36: Two Races of Left Rear-Wheel Drive Shaft Outboard Universal Joint Failed On M151A1 after 11,686 Test Miles.

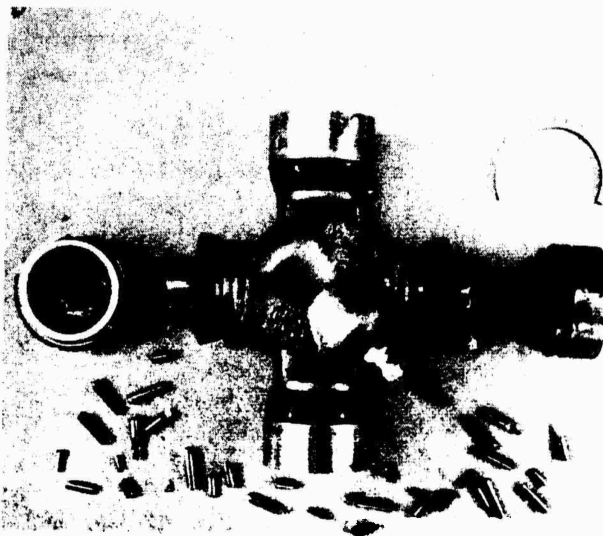
Figure III-37: Broken Race and Rollers of Right-Rear Wheel-Drive Shaft Inboard Universal Joint On M151A1 after 4155 Test Miles.

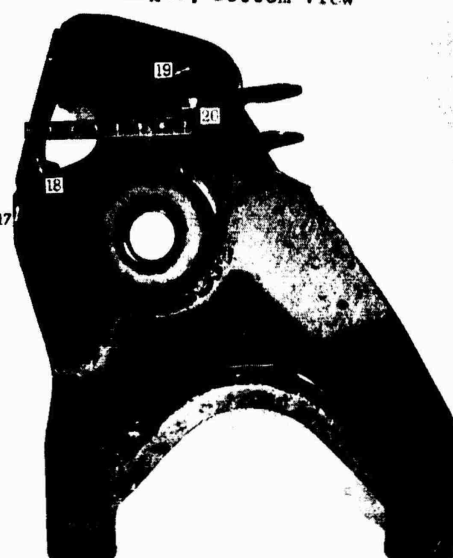
(2) The modified rear suspension test vehicles exhibited frequent power train failures (universal joints, transmissions, rear differentials, etc.) similar to those reported on the standard production vehicles, reference 1e. Several cracks and flaws (non-disabling) developed in the modified suspension trailing arms at both APG and USAARENBD. Operations were extended an additional 5000 miles at APG on the heavier M151A1C vehicle to further observe this condition. Magnaflux inspection of the suspension arms revealed eight additional small cracks, increase in the length of seven cracks and no change in six cracks. Although the cracks did not propagate to the point of failure, improvements in arm design and/or production techniques are warranted.

Figure III-38: A Typical Crack Pattern of the M151A1, M718 and M151A1C Rear Suspension Arms is Denoted by the Location of Numerical Numbers Shown on the Rear Suspension Arms of the M151A1C after 10101 Test Miles. Numbers 1 and 9 are Peculiar to the M151A1C. Magnaflux Examination Showed:

<u>Vehicle</u>	<u>No. Cracks</u>	<u>Test Miles</u>
M151A1	9	20433
	16	25276
M718	14	23563
M151A1C	17	5090
	20	10101
	III-22

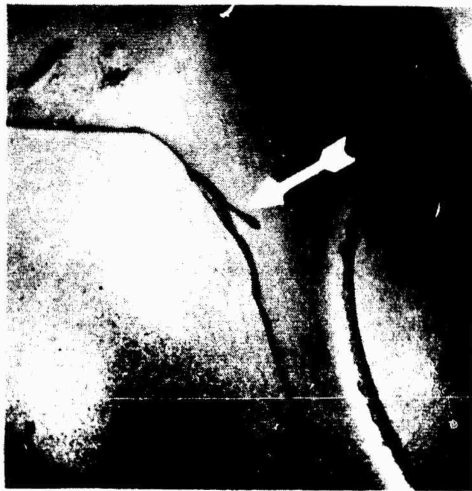
Figure III-47: Arrow Denotes 1-Inch Crack In Left Rear Suspension-Arm Assembly In the Spring Seat On M718 after 8307 Test Miles.

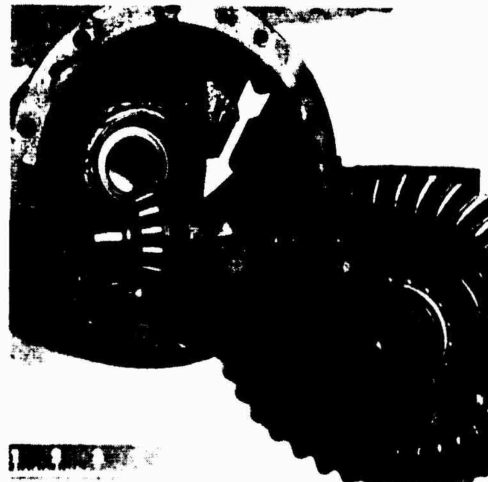
Figure III-50: Arrow Denotes Teeth Worn from Rear-Differential Pinion-Shaft Gear On M151A1C after 9625 Test Miles.

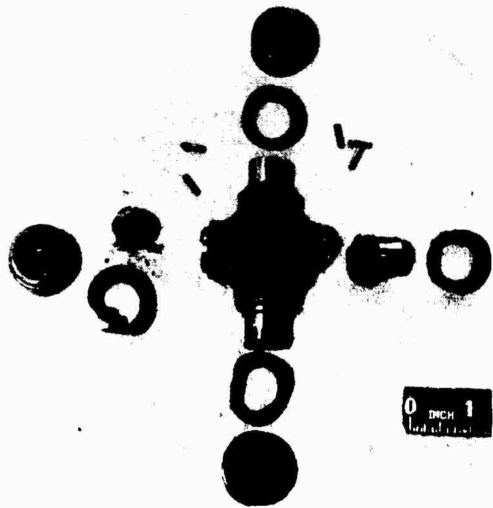
Figure III-51: Broken Left Rear-Wheel Drive-Shaft Outboard Universal-Joint Cross On M151A1C after 4189 Test Miles.

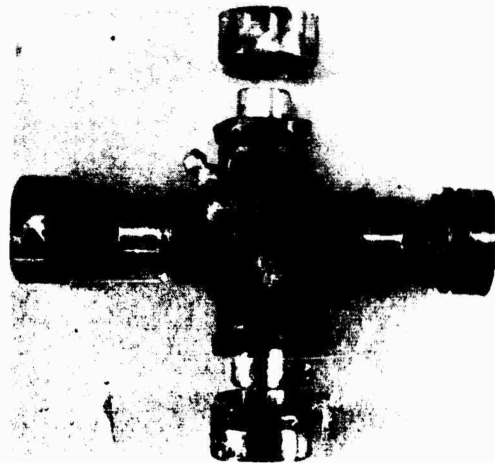
Figure III-52: Four Races of Right-Rear Wheel-Drive Shaft Inboard Universal Joint Failed On M151A1C after 3230 Test Miles.

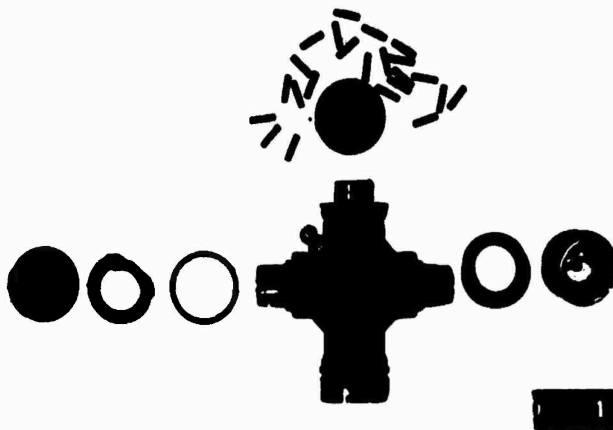
Figure III-53: Left Rear-Wheel Drive-Shaft Inboard Universal Joint (Experimental) Broken Races On M151A1C after 2147 Test Miles.

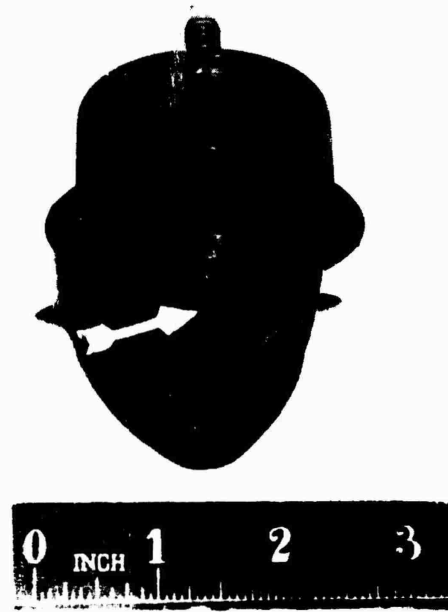
Figure III-56: Cracked Right Rear Bump Stop on M151A1C after 6872 Test Miles.

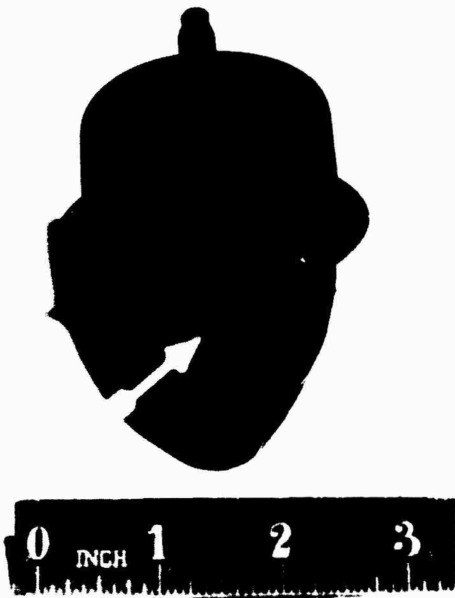
Figure III-57: Cracked Left Rear Bump Stop on M151A1C after 6872 Test Miles.

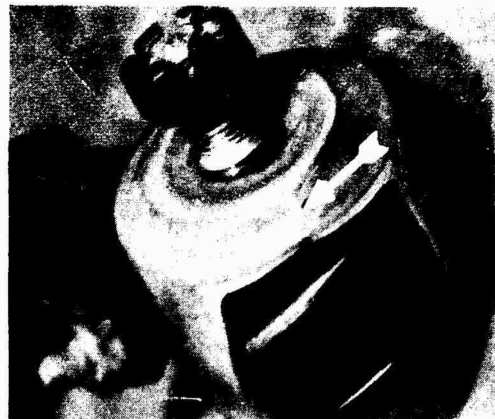
Figure III-64: Arrow Denotes 1/2-Inch Crack in Right Tie Rod-End Nylon Cover on M151A1 after 25, 276 Test Miles.

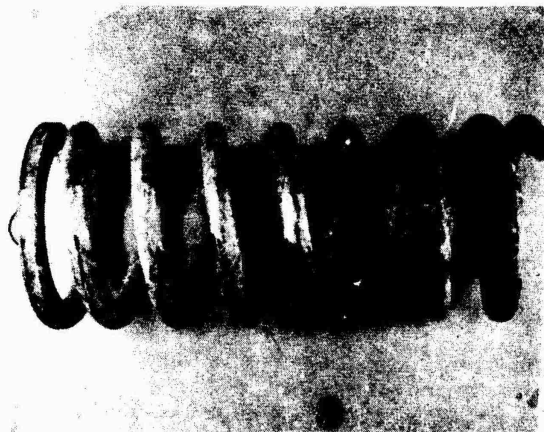
Figure III-67: Broken Right Front Spring Three Coils from Bottom On M151A1C after 2459 Test Miles.

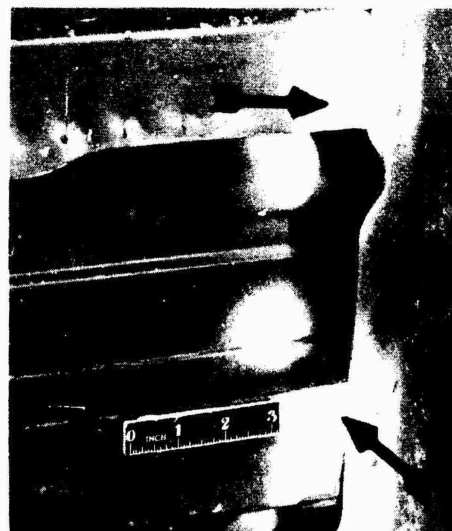
Figure III-68: Arrows Denote Inner-Frame Rail Cracks In Front of the Rear Crossmember On M151A1 at Right Inner Rail (Top Arrow) after 20433 Test Miles and Left Inner Rail (Bottom Arrow) after 23,200 Test Miles and On M718 at Right Inner Rail (Top Arrow) Similar after 19,168 Test Miles.

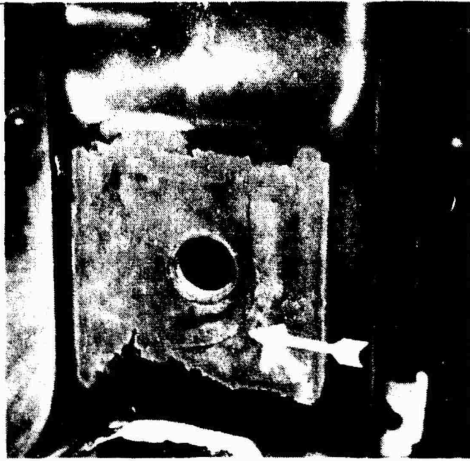
Figure III-71: Arrow Denotes 1-1/4-Inch Crack On Rear-Differential Right Rear Mounting Bracket On M151A1 after 25,276 Test Miles.
